BLADE MOLD REPAIR REPORT
1-29-14

Title: Blade Mold Pre and Post Repair

Date: 1-29-14

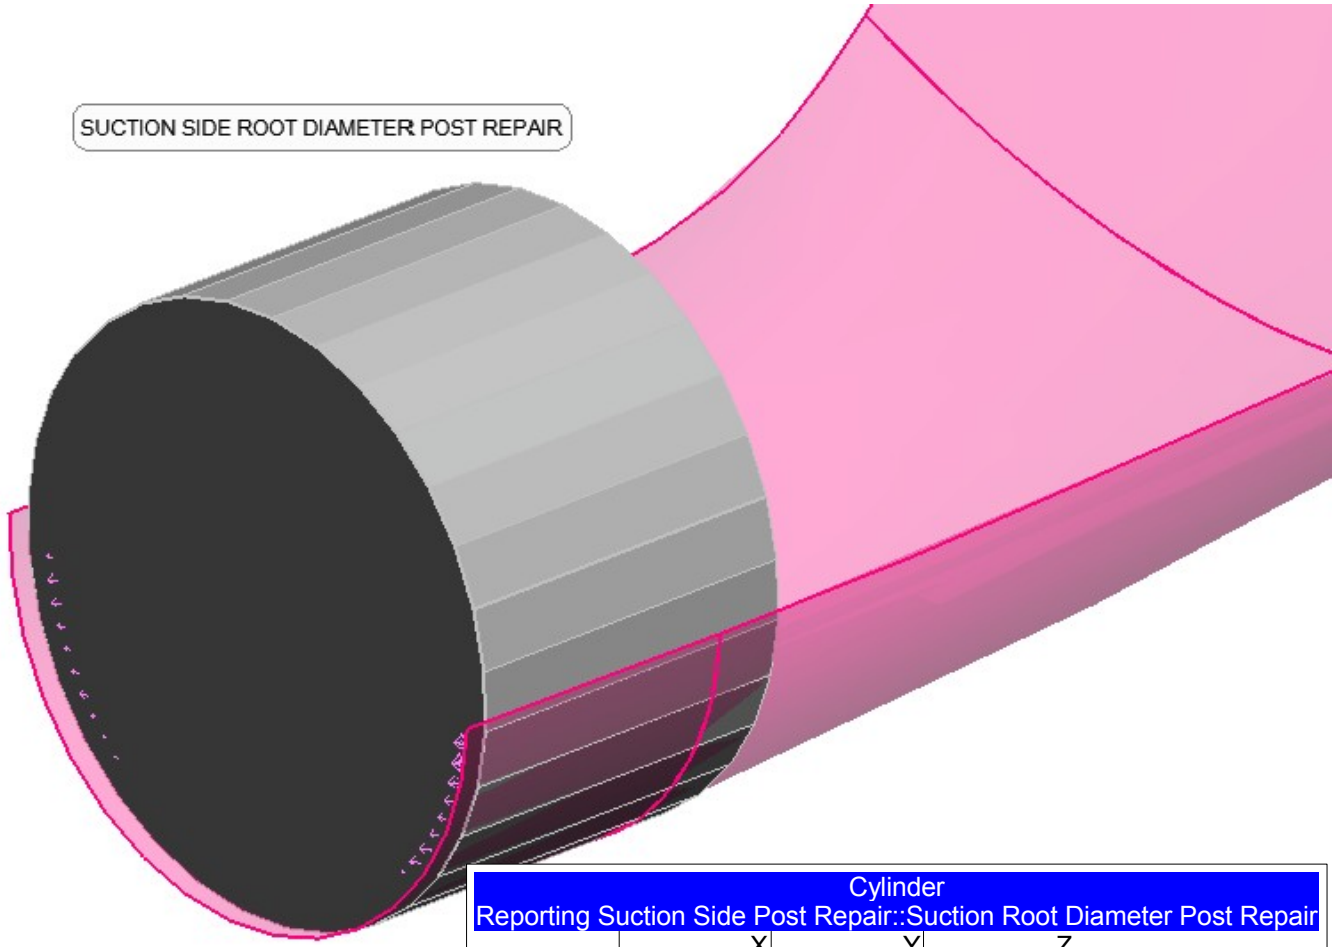
Cylinder Reporting Suction Side Post Repair::Suction Root Diameter Post Repair			
	X	Y	Z
Begin	610.7191	-259.0276	-334.5479
End	374.6260	-344.6246	-332.9807
Direction	-0.940101	-0.340839	0.006241
Proj. Ang.	Rx from Y	Ry from Z	Rz from X
(deg.)	178.9511	-89.6197	-160.0716
Radius	206.8110	Diameter	413.6219
Length	251.1359

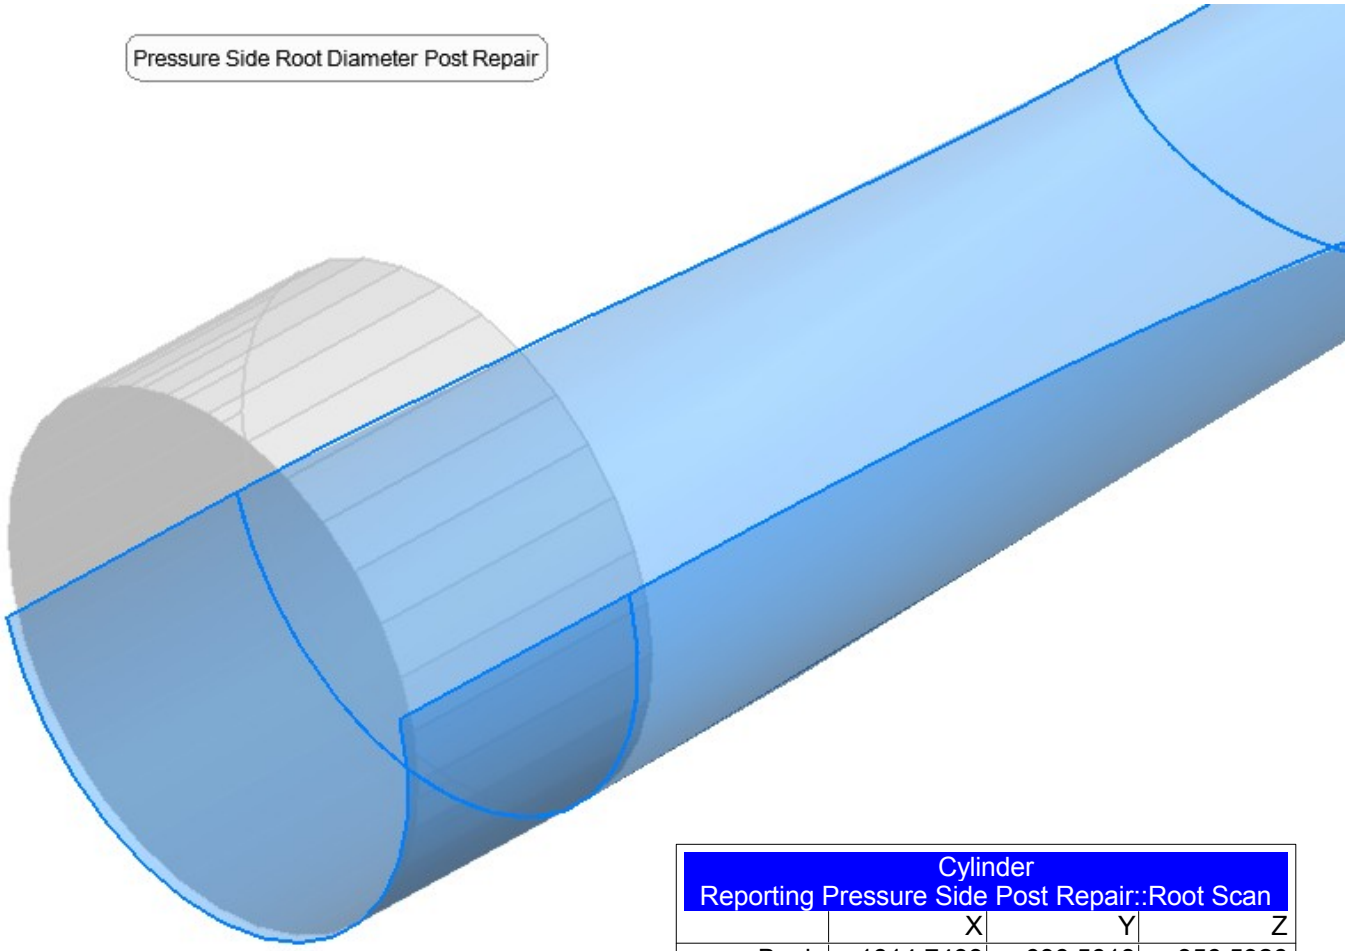
Cylinder Reporting Pressure Side Post Repair::Root Scan			
	X	Y	Z
Begin	1814.7438	-686.5618	-356.5926
End	1960.4917	-519.8760	-359.8522
Direction	0.658172	0.752724	-0.014720
Proj. Ang.	Rx from Y	Ry from Z	Rz from X
(deg.)	-1.1203	91.2812	48.8340
Radius	207.4523	Diameter	414.9046
Length	221.4436
